# Inspection Report

4XXX Inspection Drive  
Yakima, WA. 98908.

### INSPECTION CONTROL NUMBER - 9015BM012

The inspection began at 10:00 AM and was completed at about 12:30 Noon and was performed on June 26, 2009.

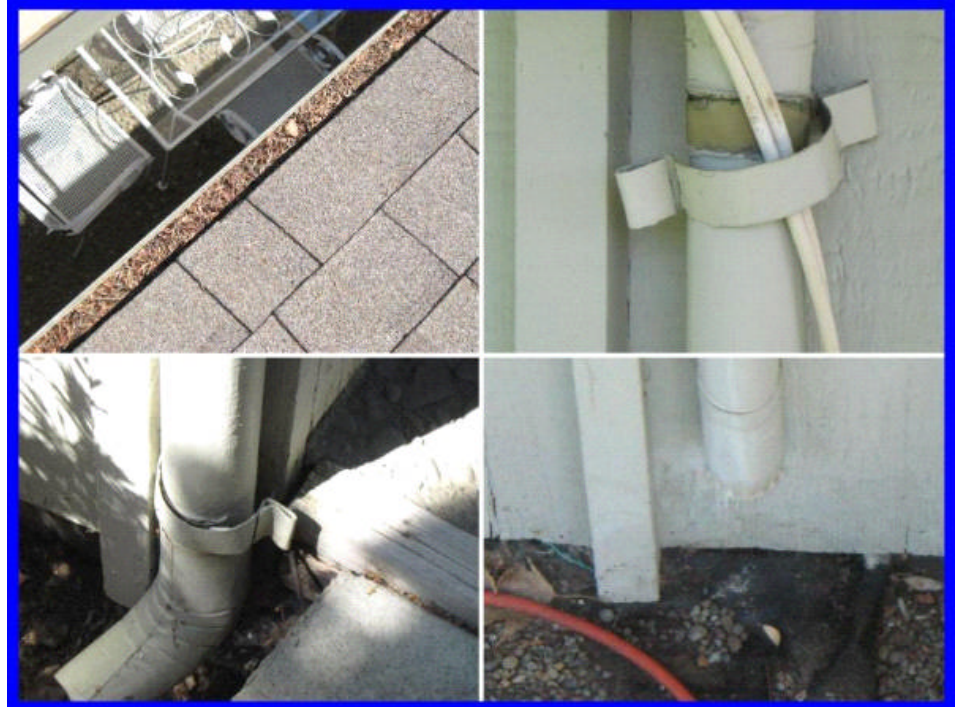
## 2.8 GUTTERS

Gutters are installed all around the home, but there are one or more problems with the gutter system: There are leaves and/or other debris in the gutters. I recommend that the gutters be cleaned as soon as possible. 2. Down spot(s) elbows are missing or were never installed at 1 place. 3. Strapping at gutter downspouts are loose, need re-nailing.

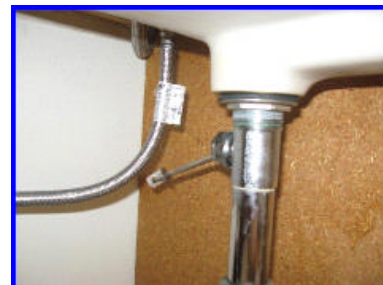
### 4.8 SINK PLUMBING & DRAIN CONDITION

The following problems were noted at the drain system: Stopper did not operate properly. They have been disconnected.

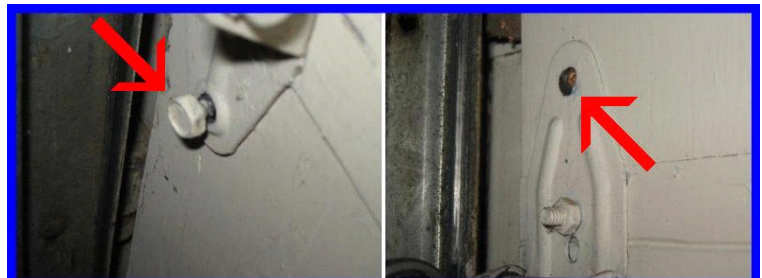
#### 8.4 OVERHEAD DOOR & HARDWARE CONDITION

Attention Needed - The overhead door needs some minor repair. Some parts of the door hardware need to be adjusted or tightened.

Loose or missing hardware

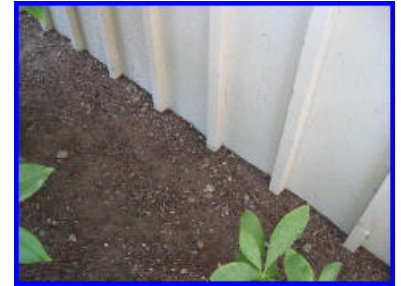
## 8.7 GARAGE WALL CONDITION

Expose the masonry foundation between exterior finished grade and the existing wall siding. All types of exterior siding should not be any closer than six inches (6") above finished grade. Proper installation will help prevent rot to the structure, moisture entering the house and insect infestation. If a foundation doesn't exist in this area it should be installed.

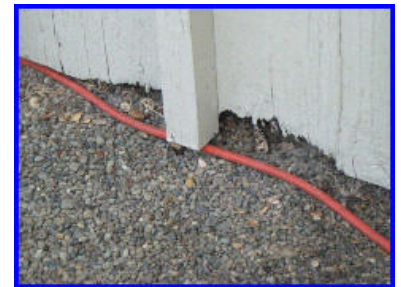
### 9.1 SIDING MATERIAL

The exterior siding is wood and it has one or more problems:  
Damaged/rotted from moisture, and earth to wood contact.

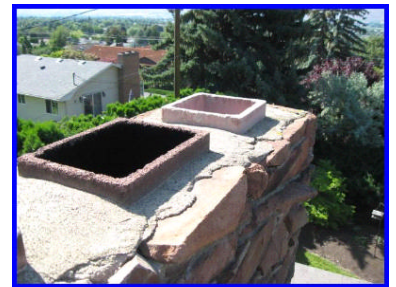
### 9.3 CHIMNEY CONDITION

The chimney is constructed from stone and it appears to have one or more problems: The crown at the top of the chimney is cracked and deteriorated from the sun and weather. The crown is necessary to protect the brick or stone from erosion or freezing damage.

Repairs recommended

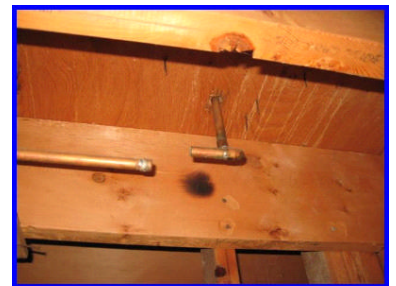
### 9.4 OPERATION

DO NOT LEAVE HOSES CONNECTED TO EXTERIOR FAUCETS DURING COLD WEATHER THIS MAY ALLOW THEM TO FREEZE AND CAUSE DAMAGE. There was one or more problems at the faucets at the exterior: Some inoperative. Recommend that a qualified licensed plumber be contracted to evaluate and make repairs before the close of escrow.

Faucet has been disconnected

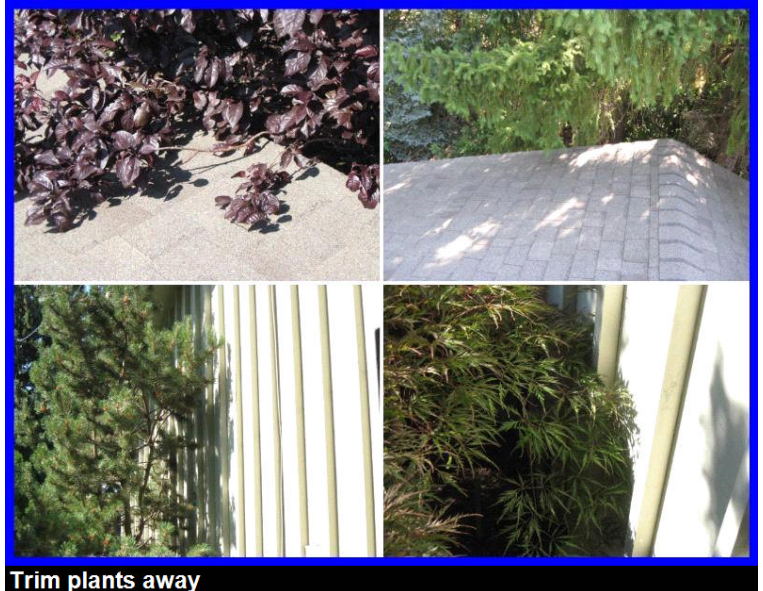
One or more problems were noted with the landscaping: 1) Trim plants away from structure, keep minimum 6 inches away. Plant contact will cause damage or rot to the siding. 2) Trees are touching or overhanging the roof. Damage is possible due to movement of branches from the wind. Branches should be trimmed away at least 2 feet from touching.

Trim plants away

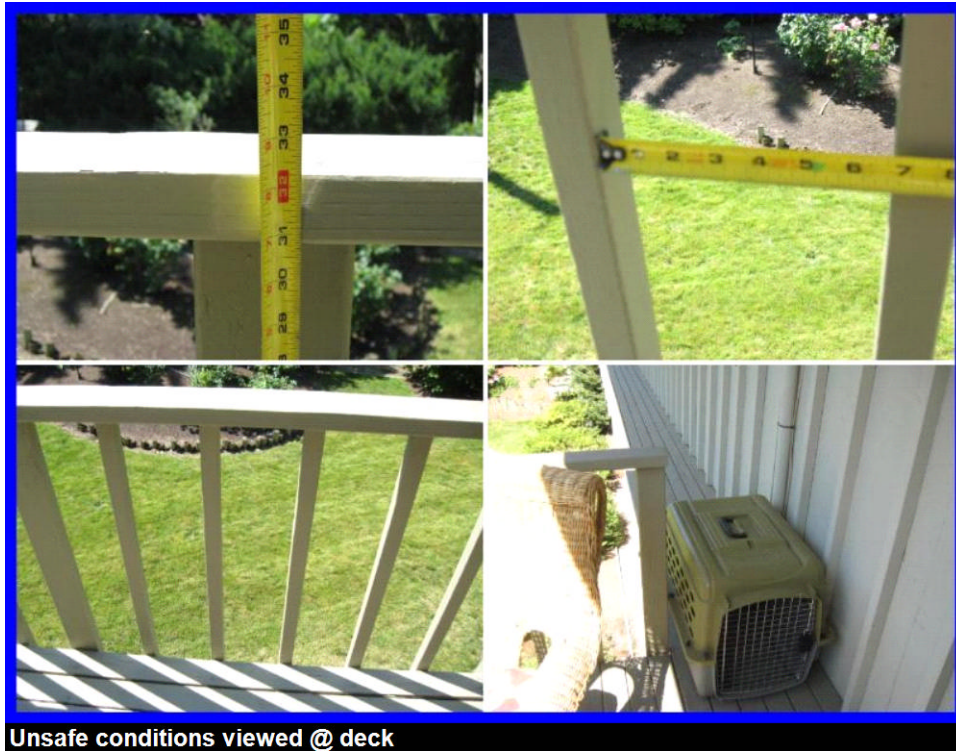
### 9.10 CONDITION

Unsafe conditions viewed @ deck

1) The current openings at the guard rail are large enough to allow a child to slip through. Any decks 30 inches or higher require proper guard rails. Recommend that guard rail spacing be reduced to less than 4 inches. 2) Decks with a height of 30 inches or more require a guard rail to prevent falling. Guard rail should be a minimum of 36 inches tall with gaps less than 4 inches.

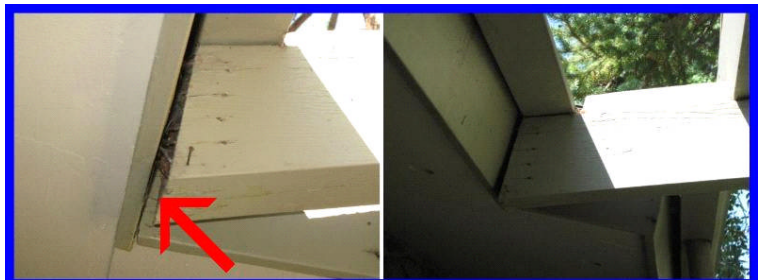
### 9.11 TYPE

Improper or inadequate support noted at patio cover. Recommend the installation of hanger brackets or other support system. Due to the conditions found I recommend that a licensed general contractor be contracted to make further evaluation and perform necessary repairs before the close of escrow.

Inadequate support at patio

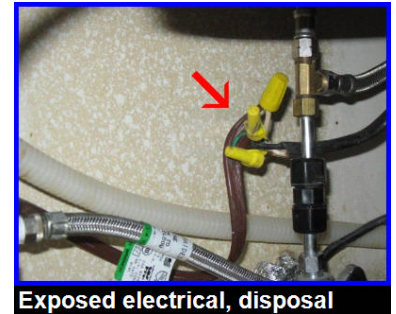
### 12.1 GARBAGE DISPOSAL

One or more problems were found at the electrical wire for the disposal: The electrical connection to the garbage disposal is made outside of an electrical junction box (open splice). Due to the problems found above a licensed electrical contractor should be contracted to make further evaluation and perform repairs as necessary.

Exposed electrical, disposal

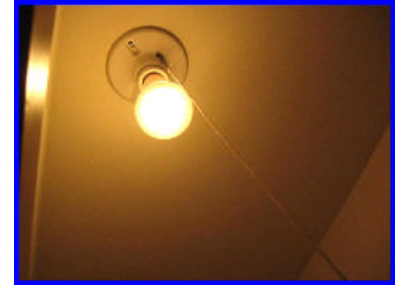
### 12.7 MASTER BEDROOM

One or more electrical problems were found at this bedroom: The incandescent light fixture at the closet is considered to be a fire hazard (materials could fall against bulb), it is recommended that it be removed or replaced with a florescent fixture.

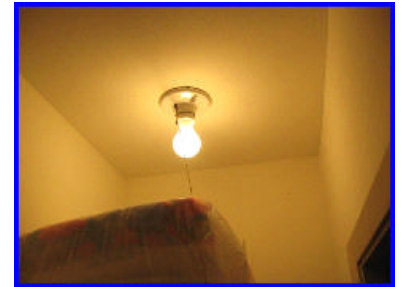
### 12.8 BEDROOM SOUTH CENTER

One or more electrical problems were found at this bedroom: The incandescent light fixture at the closet is considered to be a fire hazard (materials could fall against bulb), it is recommended that it be removed or replaced with a florescent fixture.

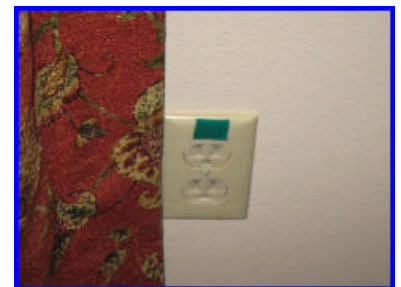
### 12.9 OFFICE

One or more electrical problems were found at this room: 1. Some grounded type outlets did not appear to be properly grounded. Affected outlets are marked with green tape. 2. The three way light switching is improperly wired and/or is not working. Recommend that a qualified Licensed Electrician be contacted to make further evaluation and perform repairs as necessary.

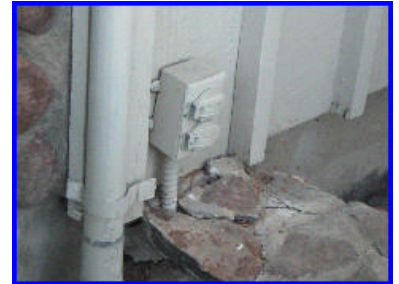
The outlets at the exterior have one or more problems: Some or all of the outlets at the exterior are not operational. Recommend that a qualified licensed electrician be contracted to evaluate and make repairs before the close of escrow.

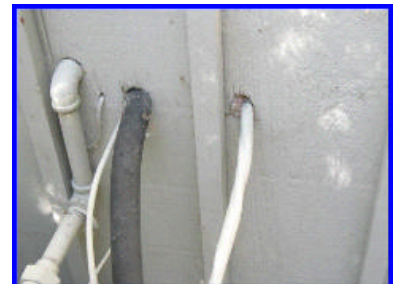
### 12.12 AIR CONDITIONING

240 Volt, 1. No disconnect provided - Recommend providing shutoff capability at unit. 2. Improper wiring electrical romex is required to be in conduit. I recommend that a licensed electrical contractor further evaluate and perform repairs.

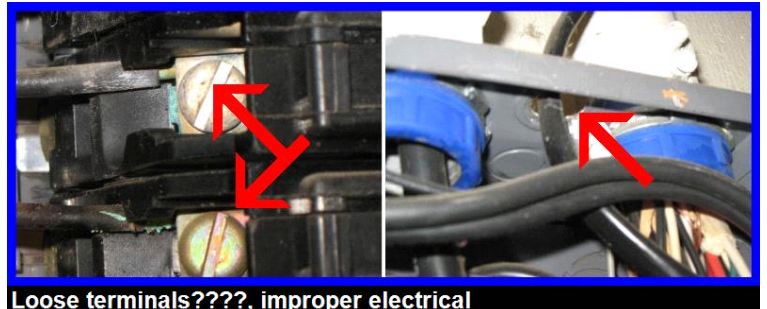
### 12.16 ELECTRICAL PANELS

The electrical panel is a circuit breaker type panel and it has one or more problems: 1) Burned or damaged wires are present, this may be due to over fusing or loose connections. 2) Knock-outs and/or box connectors are missing at interior of panel. This is a fire spread hazard in the event of an electrical fire at panel box. Fire will not be contained inside the panel box. Due to the conditions viewed it is recommended that a qualified licensed electrician make further evaluation and perform all corrections necessary to insure a safe electrical system.

Loose terminals????, improper electrical

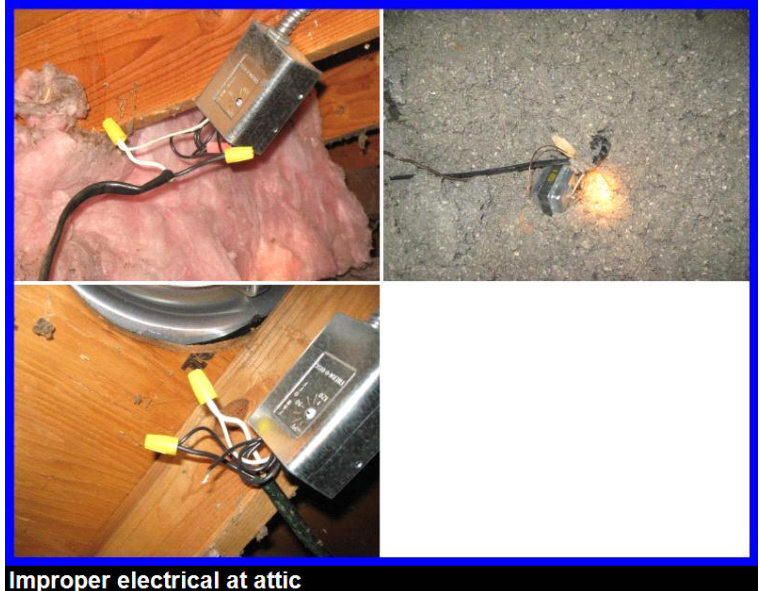
There was one or more problems with the wiring at the attic area: There is one or more open electrical splices at the attic area. This is a fire hazard. All electrical splices are required to be contained in electrical junction boxes. Recommend that a licensed electrician be contracted to make further evaluation and perform all necessary repairs before the close of escrow.

Improper electrical at attic

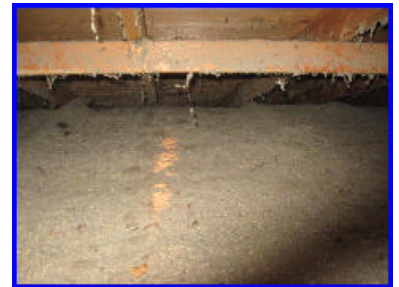
### 14.2 INSULATION TYPE - DEPTH & R-FACTOR

The insulation at the attic area is a cellulose (ground paper) blown product. The measured depth at its average lowest point was 8.5 inches, this is about R-32. As a comparison, the insulation standards for a new home in this area is R-39, or about 10 inches of this type of product after settling.

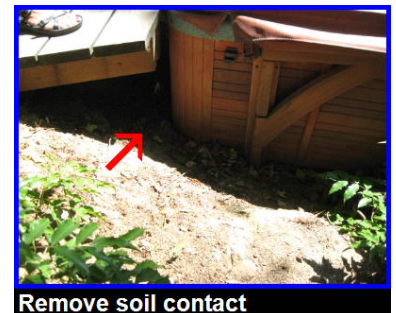
#### 16.1

Recommend that soil be removed from the side of the hot tub to prevent wood rot.

Remove soil contact
