# Inspection Report

4XXX Inspection Drive  
Yakima, WA. 98908.

### INSPECTION CONTROL NUMBER - 9015BM012

The inspection began at 10:00 AM and was completed at about 12:30 Noon and was performed on June 26, 2009.

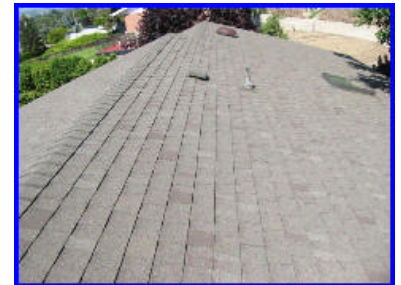
#### 2.1 ROOF STYLE AND MATERIALS

The home was constructed with a gable style roof, with 30 year fiberglass laminate composition shingles. These consist of fiberglass mat asphalt impregnated with colored gravel on surface. Shingles are applied in horizontal rows. I was able to view the roof by walking on it.

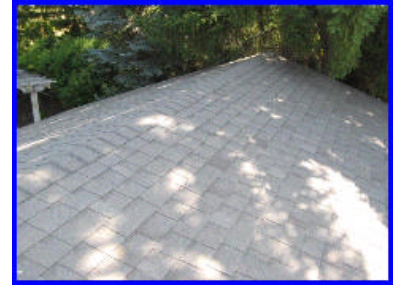
### 2.4 ROOF STYLE AND MATERIALS

The garage was constructed with a gable style roof, with 30 year fiberglass laminate composition shingles. These consist of fiberglass mat asphalt impregnated with colored gravel on surface. Shingles are applied in horizontal rows. I was able to view the roof by walking on it.

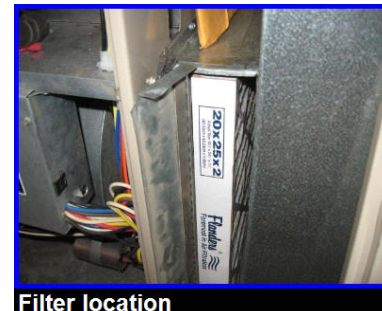
## 10.9 FURNACE AIR FILTER(S)

Appears to be performing intended function. Filter(s) should be cleaned or replaced every 90 days or less. No exceptions. Failure to do so may clog the heat exchanger systems and will decrease heating and cooling system efficiency.

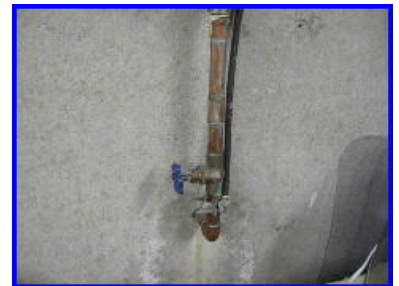
#### 11.1 MAIN LINE MATERIAL & WATER SHUT-OFF

The water supply shut off valve is located at the west side of the basement.

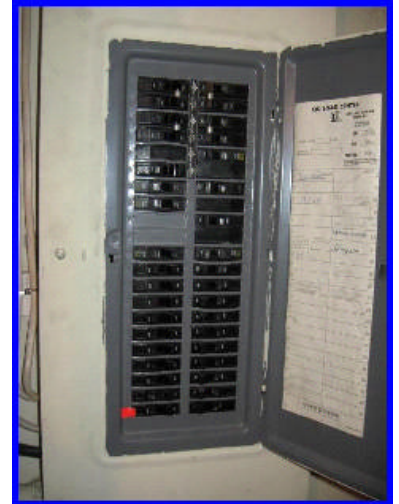
The main electrical panel is supplied by copper, number 3/0 size wire and appears to be properly installed and in good condition.

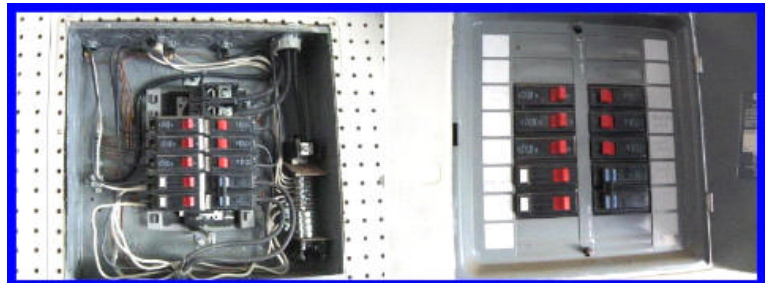
### 12.19 CONDUCTORS

The sub-panel at the garage is properly installed and appears to be operating properly.

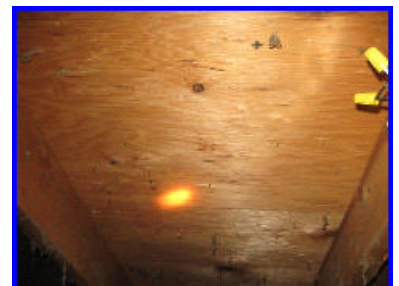
### 14.6 ROOF SHEETING

Plywood, Good overall condition.
